Access Control and Geometric Features at the Interchange Terminals with a large number of Wrong-Way Incidents: Case Studies in Alabama

CASE STUDY 1: I-65 EXIT 284 SOUTH

CASE STUDY 2: I-65 EXIT 208 SOUTH

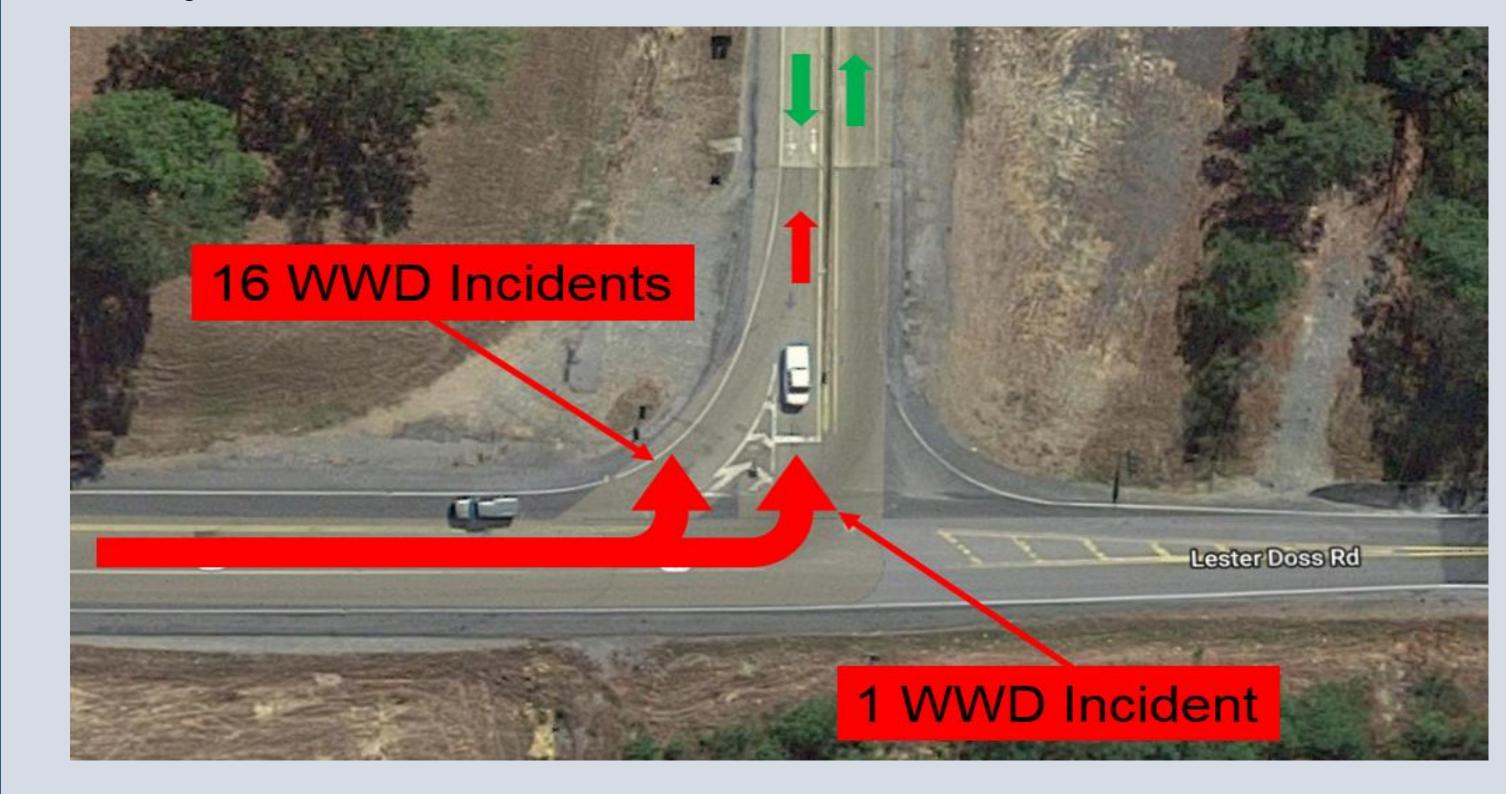
- > 17 WWD incidents in 48 hours (May 05, 2017, Friday, 5:00 PM to May 07, 2017, Sunday, 5:00 PM)
- Daytime 9 WWD incidents
- ➤ Nighttime 8 WWD incidents

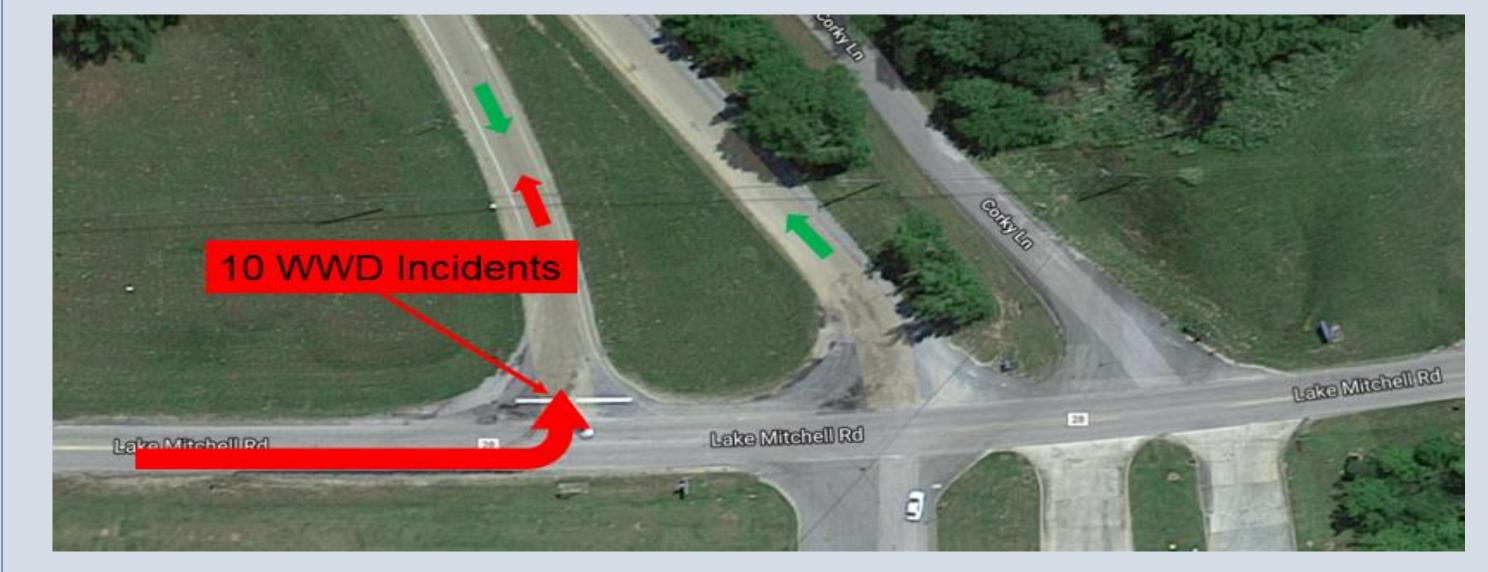
- > 10 WWD incidents in 48 hours (March 23, 2018, Friday, 5:00 PM to March 25, 2018, Sunday, 5:00 PM)
- Daytime 1 WWD incident
- ➤ Nighttime 9 WWD incidents
