ACCESS MANAGEMENT IN RURAL MPUMALANGA ON THE P17/6

ABSTRACT: P17/6 (R538) between Hazyview and White River in the Ehlanzeni district of the Mpumalanga province was rehabilitated. Construction started in November 2013, and the completion date was set for 30 November 2015. The Clients' objective was to rehabilitate the road to extend the structural life of the road with 20 years. Part of the scope was to determine the current level of service at some of the junctions and provide options to increase capacity and general safety thereof. Furthermore, the client indicated that access control is a problem on this road. The vast extending rural villages along the route were changing the road from a vehicle only route (mobility road) to a mixed vehicle and pedestrian route (activity or access street) (TRH 26, 2012). Thus, changing the road classification from a primary distributor to a district distributor or local distributor at certain sections (Guidelines for Human Settlement Planning and Design Vol II, 2000). Part of the scope was to investigate the possibilities of closing some of these accesses, combine accesses to one access point on the main road and moving property entrances away

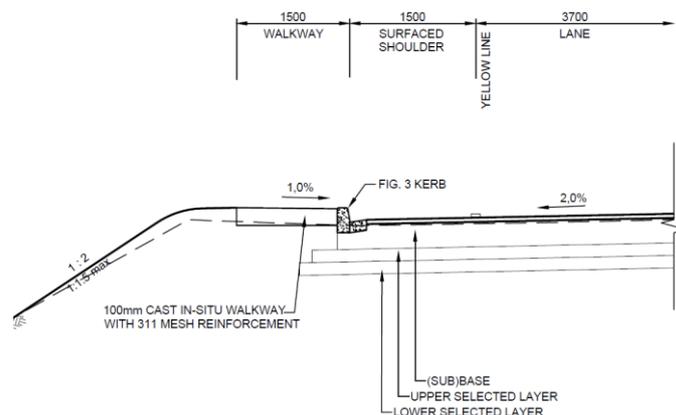
Figure 2: Typical cross section with walkway

In order to accommodate the pedestrian traffic, a continuous walkway along the road was proposed to the client. A figure 3 (barrier kerb, indicated in Figure 2) was used to divide the pedestrian traffic from the vehicle traffic and to ensure pedestrian safety. The barrier kerb was also used to control the access roads and entrances to property accesses.

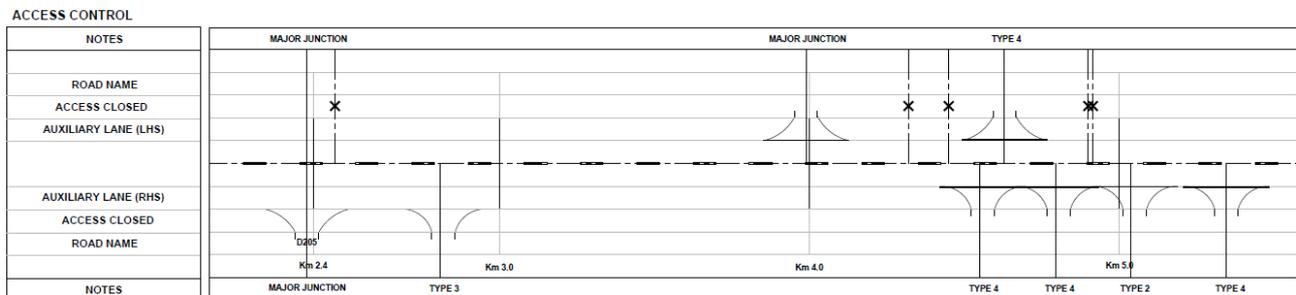
Figure 3: Part of drawing issued for construction

The sight distances of all the retained accesses were determined and the investigations were indicated on a drawing with the plan layout and aerial images to provide background, see Figure 3.

During design stage, an access management plan was created indicating which unstructured accesses should be closed and which were to remain, in addition to the type of junction to be constructed.

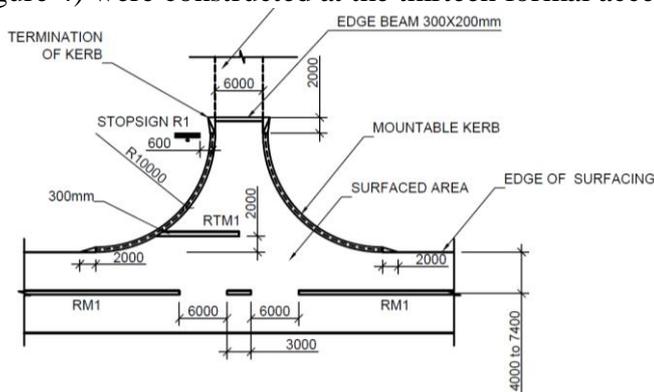
Figure 4: Surfaced formalised access (Type 2)

Three different types of accesses were identified. The first type was the major intersections (two T-junctions and two roundabouts). The second type of intersection (Figure 4) were constructed at the thirteen formal access streets.

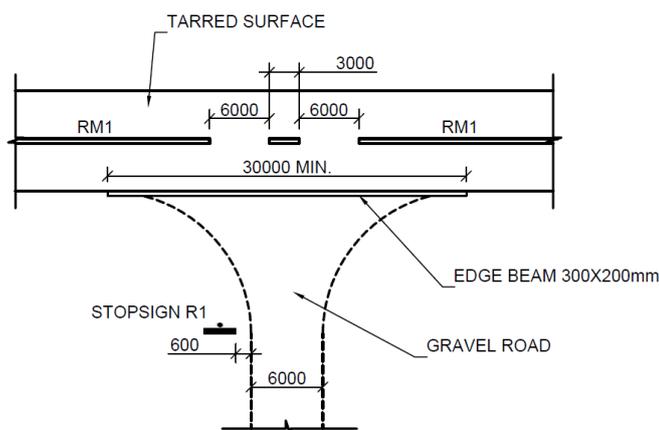
Figure 5: Formalised access to gravel road (Type 4)

The type 3 (Figure 5) intersections were constructed to formalise an unstructured informal access. The Type 3 intersections mainly formalised the gravel road junctions and the driveways with an edge beam. Sixty of these accesses were constructed as indicated in Figure 6.

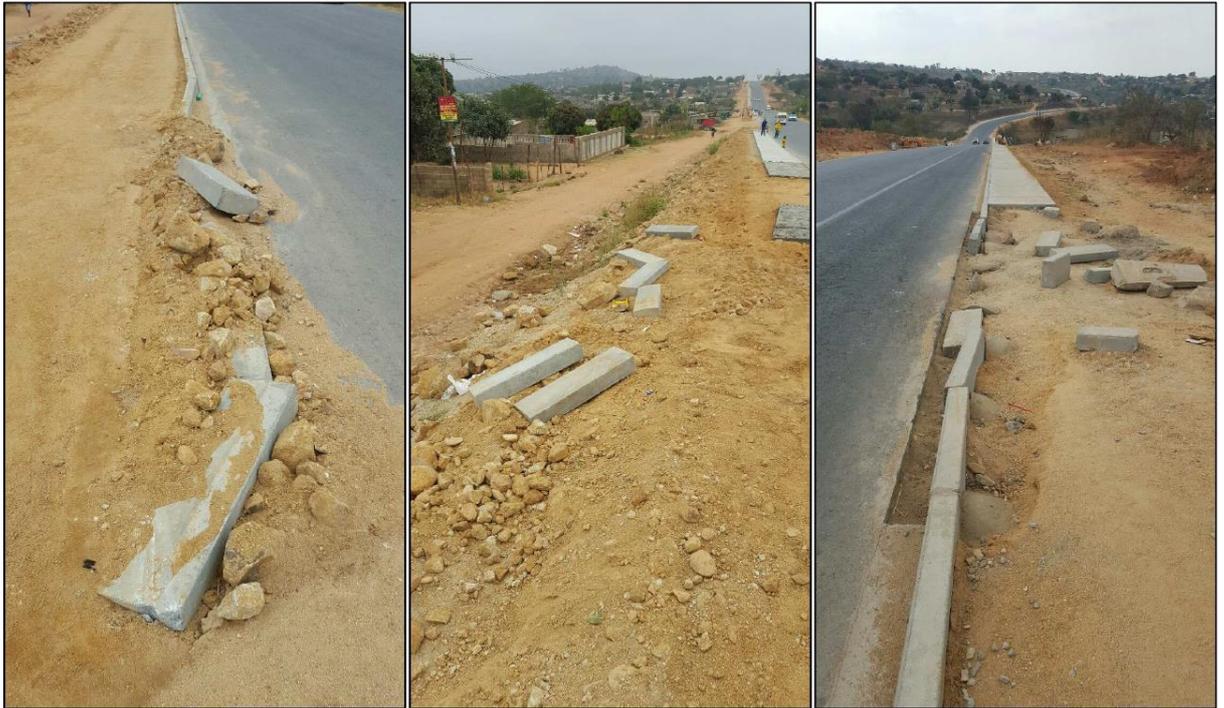
Figure 7: Kerbs broken by community

The local community was perceived as uncooperative, and intolerant regarding the construction. As soon as the first access were closed, the community demolished the closures (see Figure 7). Furthermore accounts of intimidation and violence towards the main contractor and the subcontractors were documented.

This caused problems as the walkway production was on the critical path at that stage and the community stopped the work. With the help of a social facilitator, Community Development Workers (CDW) of the area (including the respective Ward Councillor in the area) some of the community members were persuaded to agree to a gravel service road that leads to an access which is safe to enter the main road. However, a few community members were adamant and were provided direct access to the main road.
