# Quantifying Countermeasure Effectiveness

Pedestrian and Bicycle  
Information Center

## Quantifying Countermeasure Effectiveness — Orlando, FL

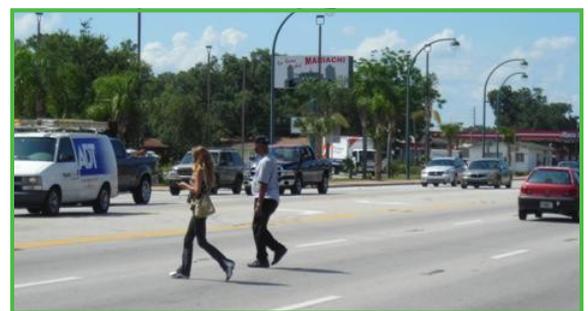
Pedestrians crossing through holes in traffic on a six-lane arterial.

Most pedestrians do not cross in gaps; they cross in holes. A gap occurs when a walker can step into the roadway and reach a place of safety before any car crosses his path. A hole, on the other hand, occurs when there is traffic in the middle or far lanes in front of the pedestrian, or when a car in a near lane is so close it will pass behind the pedestrian before she completes the crossing. As long as motorists behave as the pedestrian expects, a hole crossing may be made without incident. If conditions change — for example, if a car changes lanes — the expected hole begins to close and a crash may result.

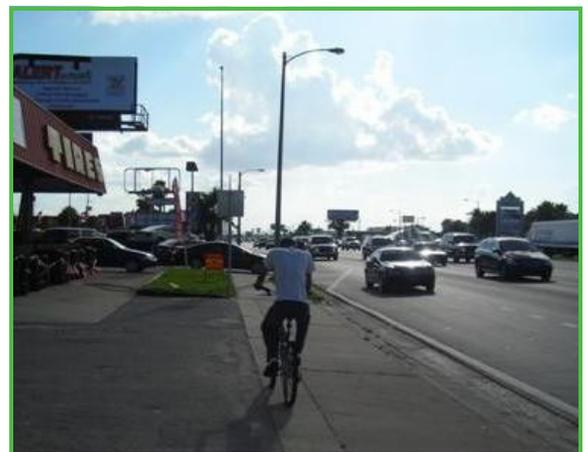
A bicyclist traveling on the sidewalk against the flow.

Cycling against the flow of traffic (sidewalk or roadway) was found to be 4.4 times riskier than traveling with the flow. Cycling on the sidewalk (with or against the flow) was found to be 1.6 times riskier than on the roadway, but this is largely attributable to the high number of sidewalk cyclists traveling against the flow.
